HOUSATONIC RIVER BASIN
ANSONIA, CONNECTICUT
QUILLINAN RESERVOIR DAM
CT 00024

PHASE I INSPECTION REPORT
NATIONAL DAM INSPECTION PROGRAM

February 1980

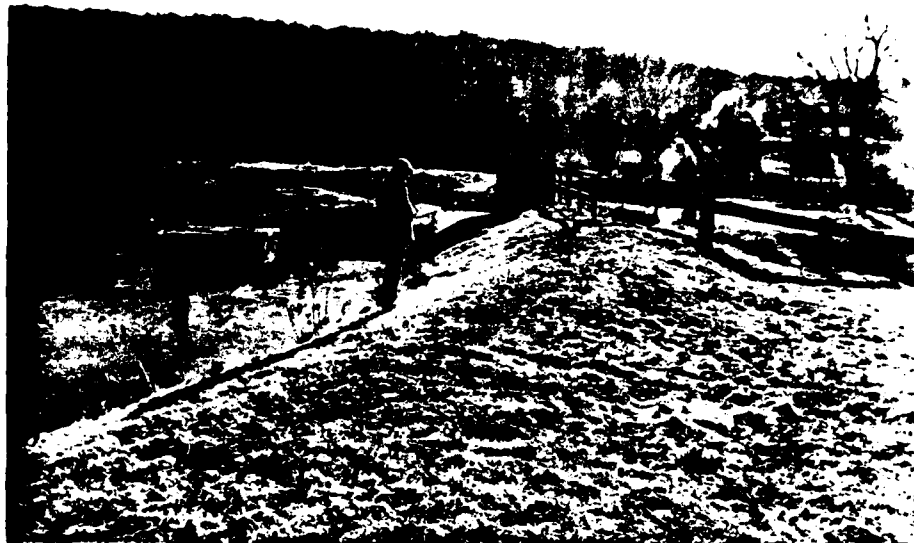
Upstream Slope - Erosion was noted along the water line of the upstream slope of the left section of embankment (Photo 1 and 2). This erosion extends from the riprap protection (just below the water line) to 3+ feet up the slope. A small area of erosion was also noted at the embankment to the right of the spillway. This area is 4+ feet long and is located at the water line just opposite the supply intake and gate tower. Small brush was also observed on several portions of the upstream slope.

Photo 1 - Upstream slope and top of dam from right abutment.
Gate structure for supply intake at left (Jan. 1980)

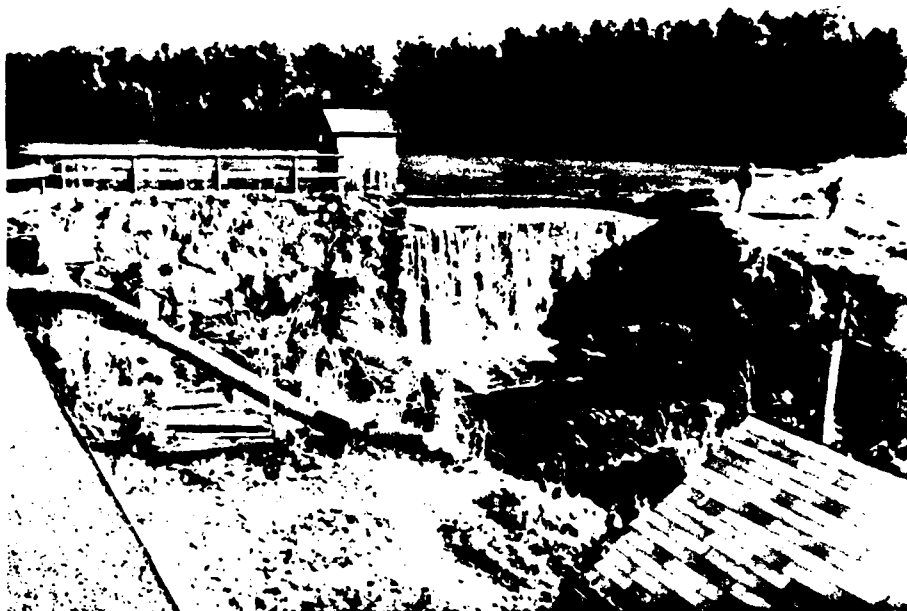
Downstream Slope - The downstream slope of the masonry section is covered with grass, weeds and brush, which is growing out between the masonry joints of the stone masonry (Photos 3 and 5). Seepage through the joints was noted at the lower portion of the masonry section and in several joints approximately 7 feet below the top of the masonry. The total seepage flow is approximately 0.5 to 1 gallon per minute (gpm). Many of the joints in the masonry are cracked and leaching at the areas of seepage, leaving the mortar soft and non-cohesive (Photo 6). The toe of the masonry section is also wet and covered with brush (Photo 3). The downstream slope of the left earth embankment has a grass cover with some brush. No cracks or seepage was observed.

Spillway - The downstream face of the masonry spillway is slightly deteriorated near the top. The spillway crest is in good condition. The spillway apron is severely damaged with spalling at the central and left portions (Photo 3). A scour area in the discharge channel approximately 2 feet wide and 2 feet deep was noted along the toe of the spillway apron.

Photo 3 - Downstream face of masonry section with spillway (Jan 1980)

5. Cracked masonry joints of the spillway training walls should be sealed to prevent further deterioration.
6. The concrete damage at the spillway apron should be repaired or the apron replaced. Erosion at the toe of the apron should be filled and riprapped.

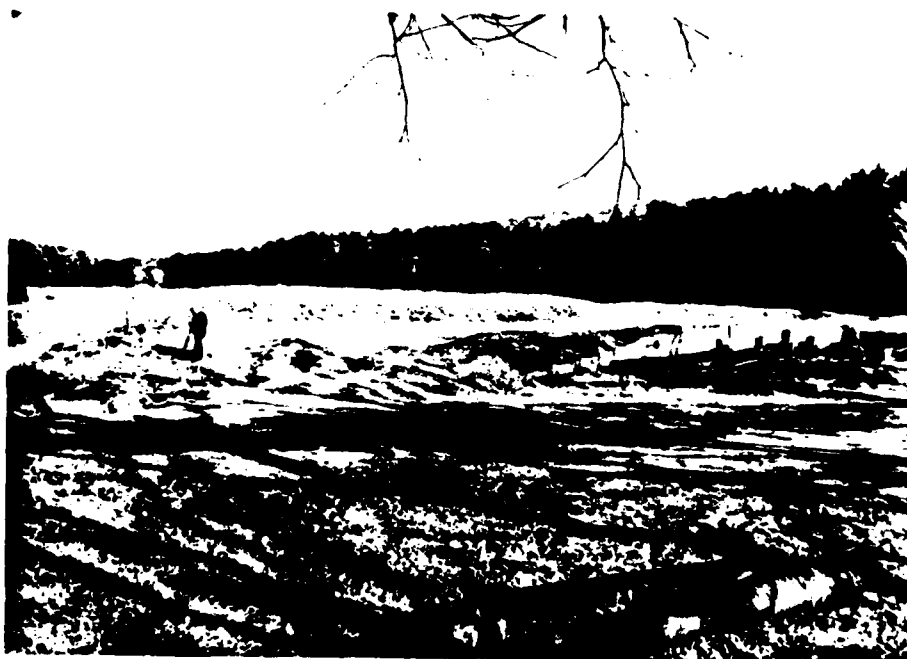
Photo 4 - Downstream slope of embankment left of spillway.
Note irregularity of crest. (Jan. 1980)

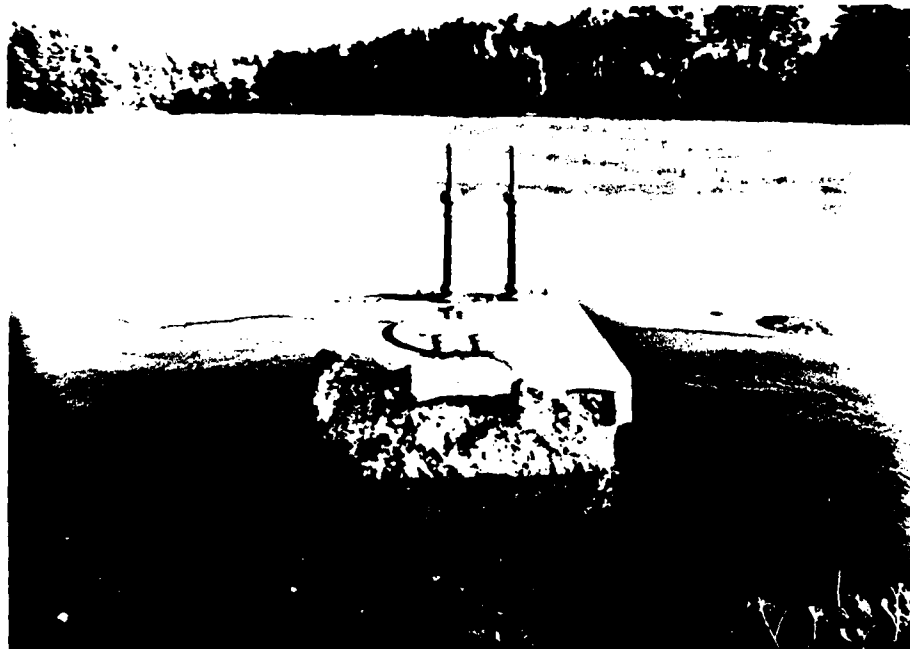
The concrete gate tower for the supply intake is deteriorated; including exposed aggregate, severe spalling, and cracking (Photo 8).

Photo 8 - Gate structure for supply intake (Jan 1980)

5. Repair of the concrete intake and gate tower for the supply line.
6. Origin and significance of seepage at the abandoned chlorinator chamber and location of the 4 inch drain pipe.
7. A comprehensive program for further investigation of the dam. Of particular importance are:
 - a. Condition of the masonry spillway and the concrete apron when no water is flowing over the spillway. This should include investigation into the extent of the scouring at the toe of the apron and the affect of this erosion on the stability of the concrete apron.
 - b. Effect of the fill at the toe of the left embankment on possible seepage through the dam and monitoring of this seepage.
 - c. Development of a program to reduce or stop seepage through the masonry section of the dam.

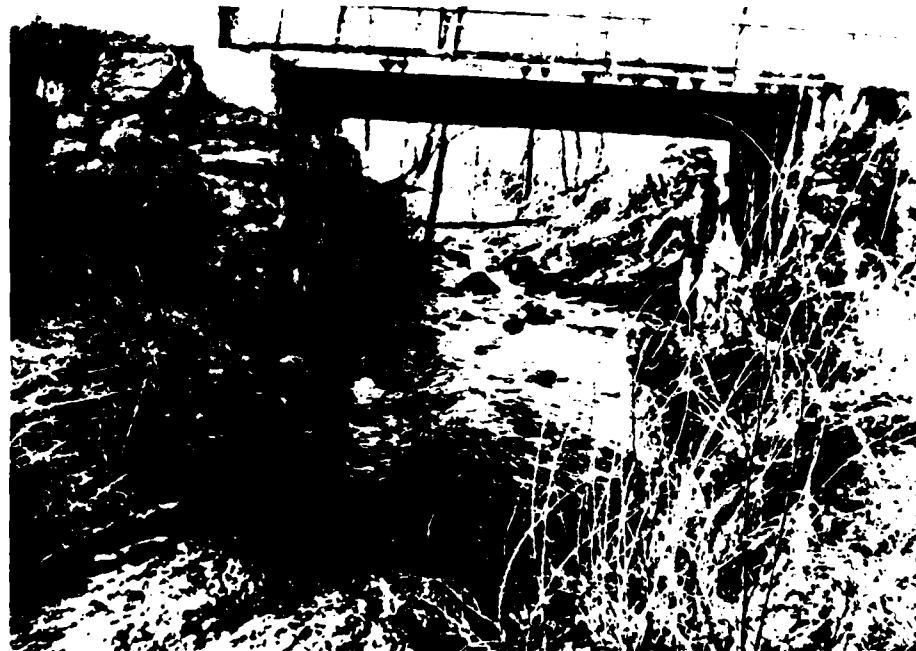
Photo 10 - Downstream channel from spillway (Jan 1980)
